## SAFETY ALERT BULLETIN

### SURFACE HAULAGE ACCIDENT

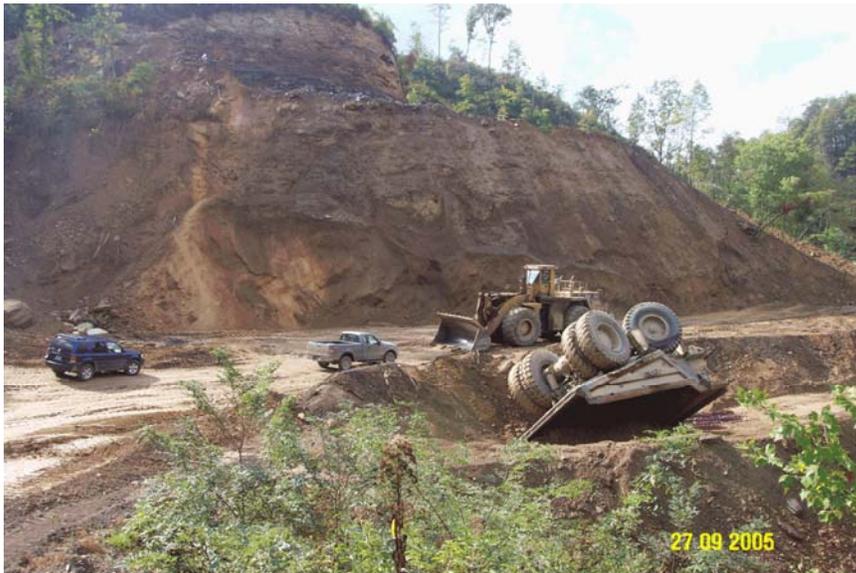
The driver was hauling spoil material, **in reverse**, from the loading point to the dump point which was approximately 250 feet away. While hauling the last load of the shift, the driver contacted the berm for a distance of approximately 30 feet before the berm and bank of a newly constructed pond gave way and the Triple 7 Hauler turned over into the dry pond.

- Always wear seat belt when operating mobile equipment.
- When possible, limit travel in reverse. The work area should be designed to keep reverse travel to a minimum.
- Always remain vigilant and be constantly aware of your surroundings.
- When reverse travel is necessary, constantly observe the area behind you by using the rear view mirrors.
- When traveling in reverse keep a maximum distance between the vehicle and the berm.
